Intercontinental Terminals Company (ITC) Fire Update
Deer Park, Texas
April 26, 2019 0000 – April 28, 2019 1159

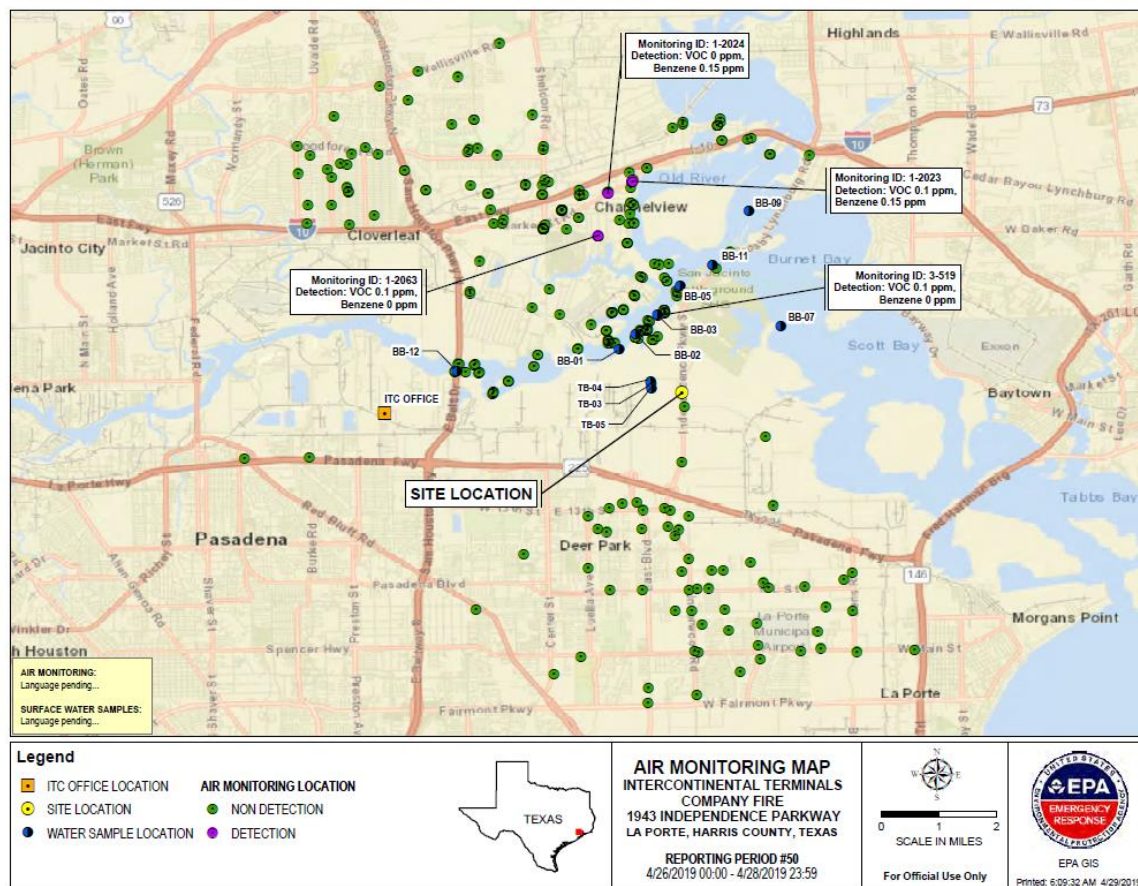
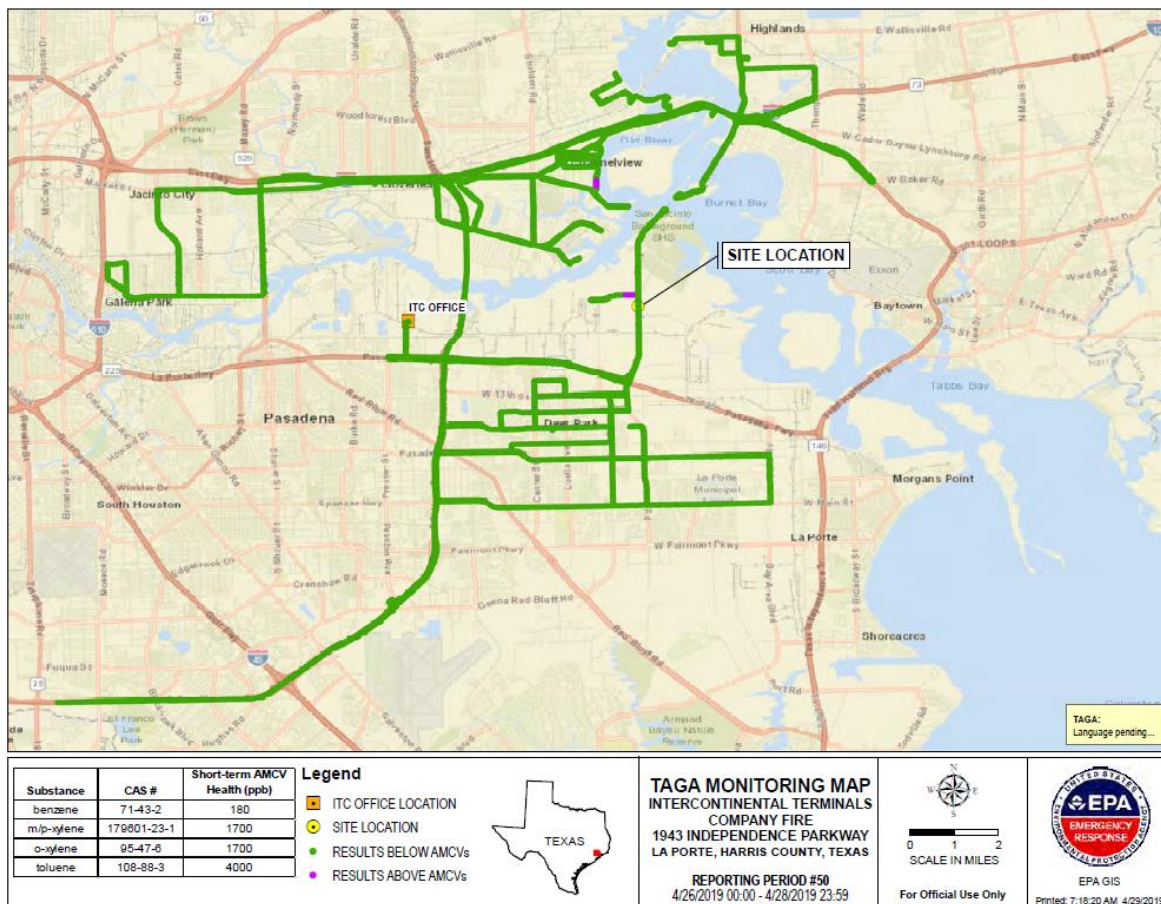
Additional Information: Air Monitoring and Water Sampling locations:

- EPA conducted surface water sampling on April 26, 2019, April 27, 2019 and April 28, 2019 at 11 sample locations. The surface water samples were collected in Tucker Bayou and along Buffalo Bayou and the San Jacinto River and will be analyzed for per- and polyfluoroalkyl substances (PFAS), volatile organic compounds (VOCs), semi-volatile organic compounds (SVOCs), chemical oxygen demand (COD), and oil & grease. The results from the sampling event will be compared to the TCEQ Surface Water Quality Standards (WQS), or to TCEQ Texas Risk Reduction Program surface water protective concentration levels (PCLs), if a WQS is not available for a chemical. No exceedances have been observed since April 2, 2019.

- Several entities including TCEQ, EPA, and ITC continue to conduct air monitoring around the tank farm, in adjoining industrial areas, and communities downwind from the facility.
- EPA conducted handheld air monitoring from April 26, 2019 at 00:00 to April 28, 2019 at 23:59 at 273 locations in the surrounding communities. Results were reported above the detection limit at three locations for total volatile organic compounds (VOCs) and at two locations for benzene. EPA will continue to conduct additional air monitoring and deploy
